Berkshire Golf Club

Case Study

Complete re-roof of an operational club house

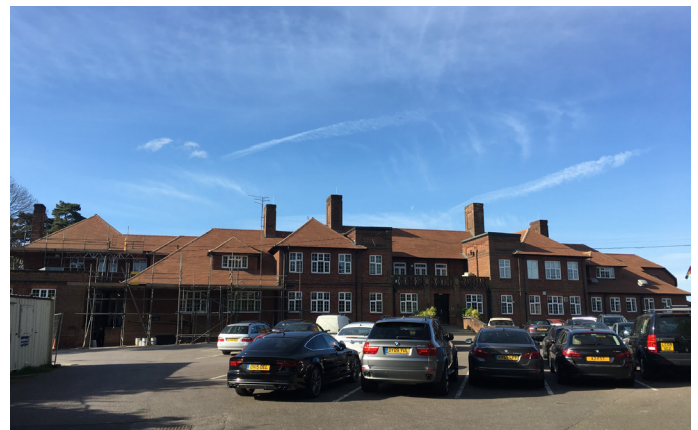
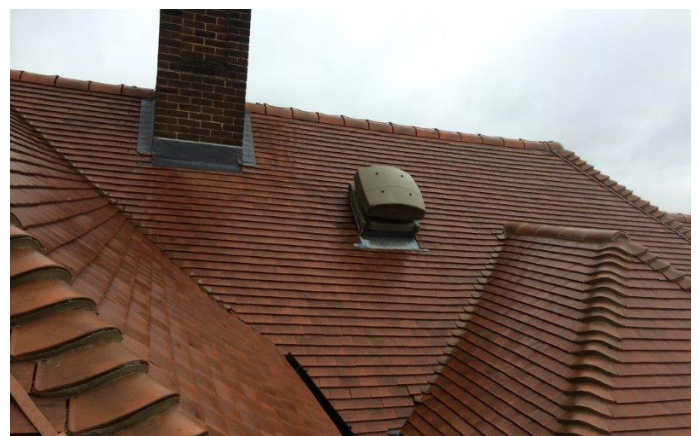
This project comprised the complete re-roofing of the golf club's club house. The original peg tiles had crumbled over time so were removed and replaced with new clay tiles. Vintage Val De Seine tiles were used to match the existing building, while new breathable felt was installed underneath.

Detailed work included mitred bonnet hip cuts, tile hanging around the dormer windows and intricate lead work with chimneys and flashings. Bat access tiles were also included on the roof as per the Ecologist's report with temporary bat boxes placed around the course while the works were ongoing.
